The Hilltop, Donated by Mildred and Hale Whitaker Historic Structures Report Lakeside Linkage Preserve

Historic Structures Report - Lakeside Linkage Preserve
Contract #522677 Task Order 1, Task 3

ICF Jones & Stokes
April 2008

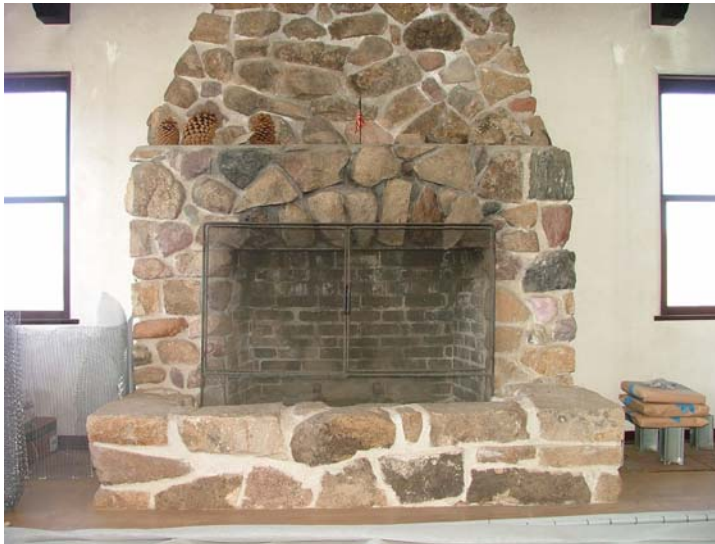
Figure 4. Fireplace, composed of local rock.

The original light fixtures and design elements located on the exterior and interior of the house (see figures 1-9) appear to be original and are in good condition. Some of the interior details include a wood beam ceiling in the large living room, decorative metal peephole on the front door, and a large intrusive fire place that is composed of the same local rock, all of which appear in good condition.

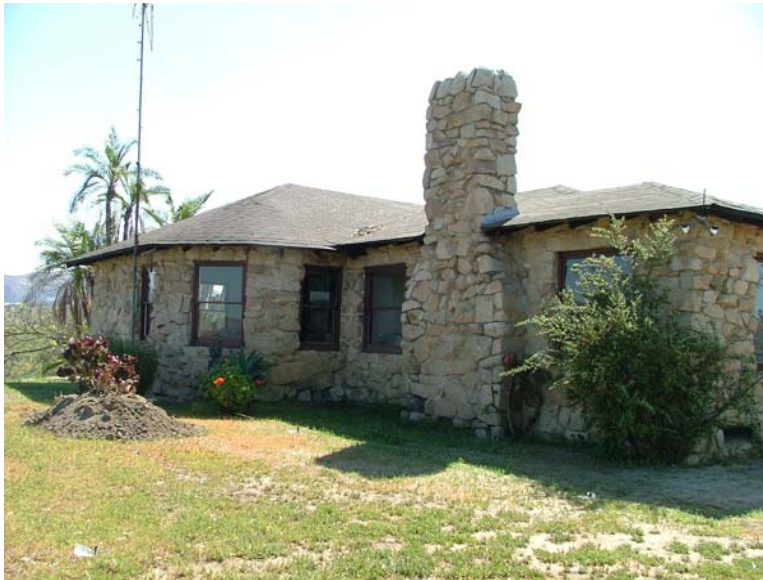
Figure 10. North Elevation

North elevation is dominated by rock chimney and features an unusual $\frac{1}{4}$ round wall with conical roof element.

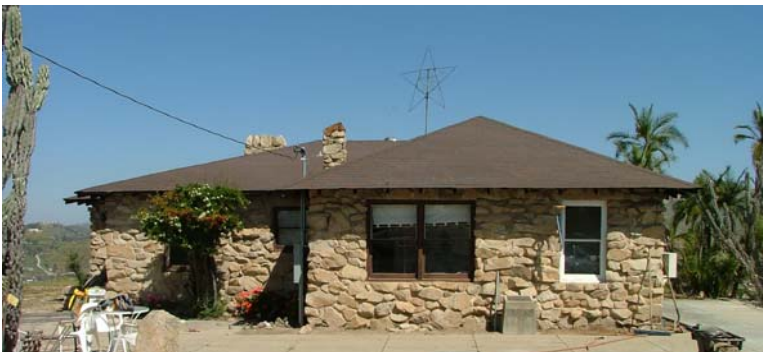
Figure 11. South elevation

South elevation is in three facets. Front door is anything but grand. A modern marker has been added next to this elevation commemorating the Whitakers and their love of this place.

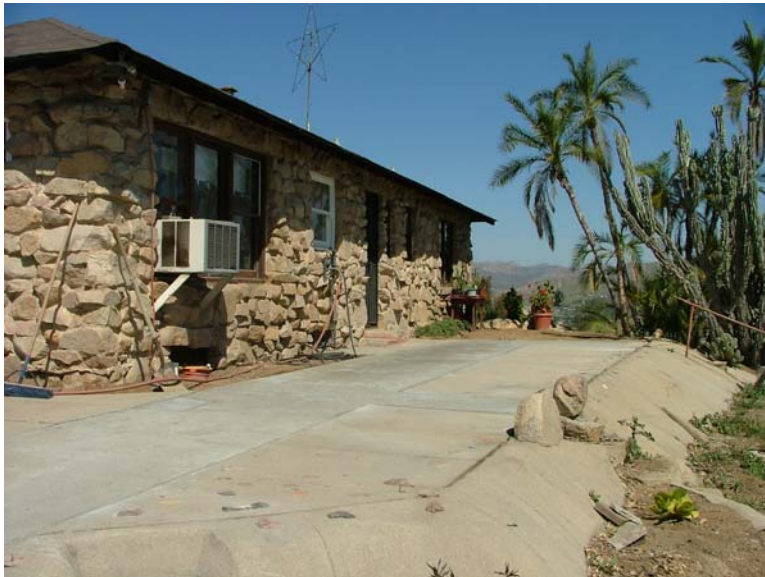
Figure 12. East elevation

East elevation was probably the functional entry for the residents as the entry door leads into a service porch with its own utility sink. The house has no heat other than period electric wall heaters in the bathrooms. A window air conditioner has been fitted into a corner of the dining room.

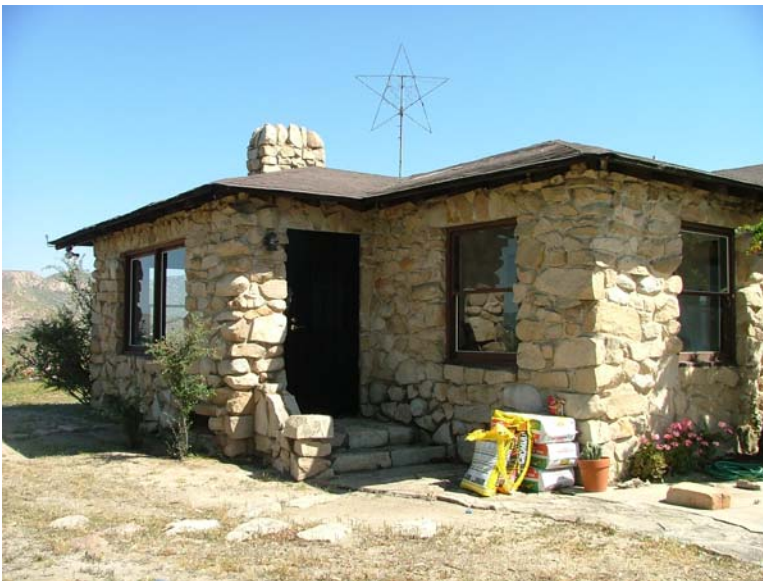
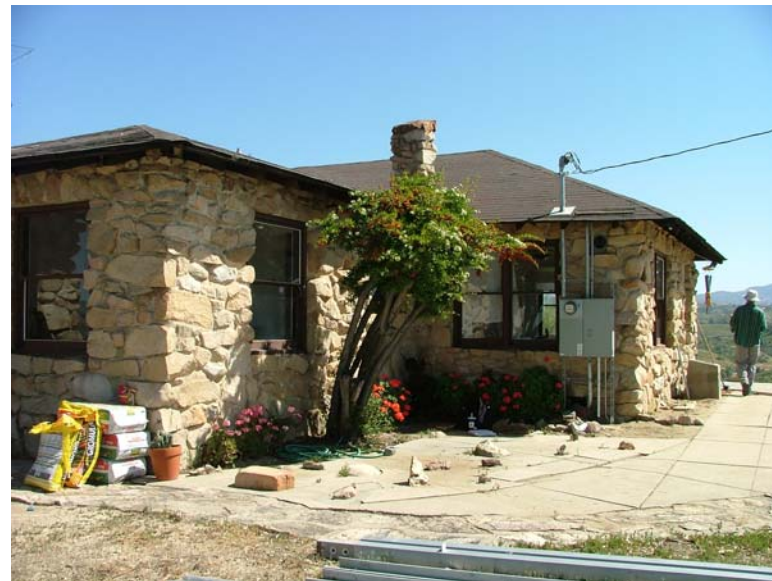
Figure 13. West elevations

modifications to provide for visitor safety and to comply with the ADA. In addition, the Department of Parks and Recreation (DPR) would like to move electrical panel to another location on building in order to retain the original design for the primary elevation.

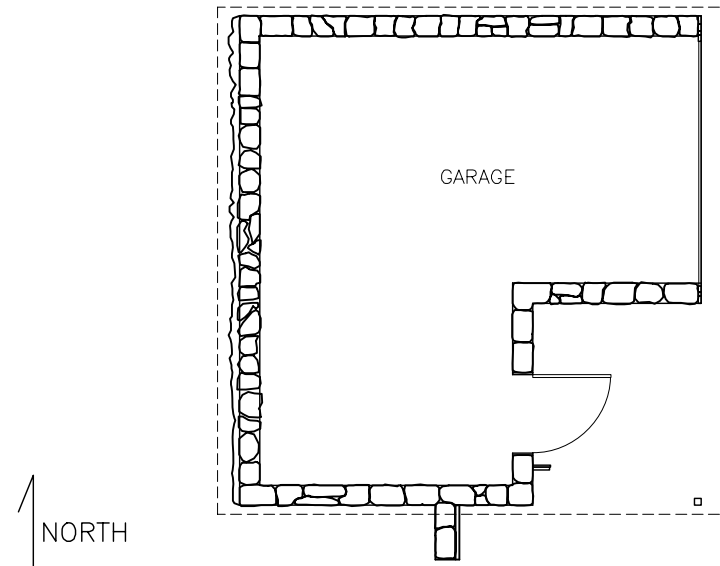
Figure 14. Photo showing relationship of Garage to House

The garage shows some signs of neglect; the roof structure is beginning to come apart. However the damage is not major and is well within the skill set of any carpenter to affect matching repairs.

The garage is at some distance from the house and is quite small. This structure was likely used to house grounds keeping equipment, perhaps a tractor; not likely used for an automobile.

As mentioned previously, the garage roof framing is in need of a small amount of immediate repair. Other than that the two buildings are in sound stable condition and no other maintenance is called for immediately.
